Manhole Inspection Summary

Manhole # S43EE_012MH

Record Plat: **43EE** Node: **012** Status: **Found**

Location Address: **1703 CHASE ST** Cross Street: **MCDONOGH ST**

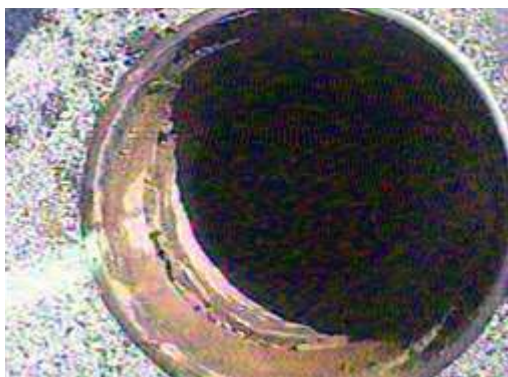
Defect 5

Frame Offset: **1** (in.) Condition: ☒ Sound ☐ Cracked ☐ Leaks

frame offset

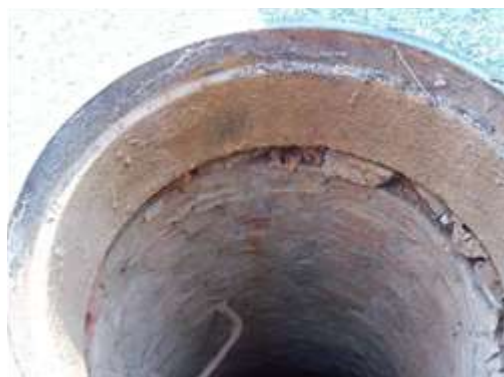
Defect 3

Steps Count: **4** Missing: **0** ☒ **Corroded**

corroded steps

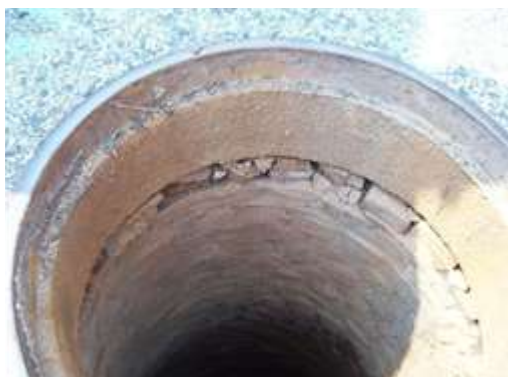
Defect 2

Condition: ☐ Sound ☒ **Cracked** ☐ Root Intrusion ☒ **Loose Brick** ☐ Deteriorated

chimney loose bricks

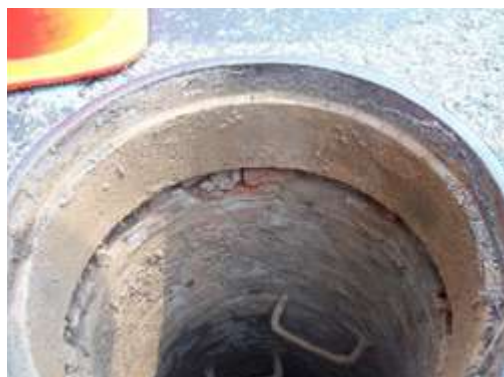
Defect 1

cracked

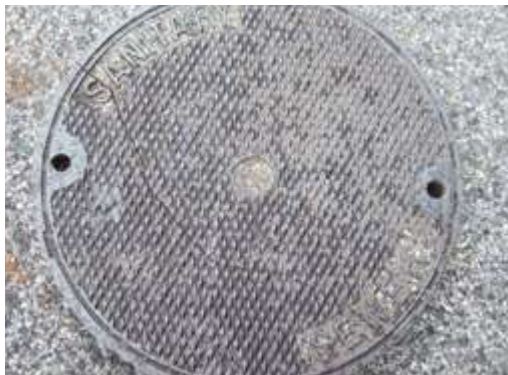
Defect 4

Type: **Sanitary** Condition: **Cracked** Cover Material: **Cast Iron**

CRACKED COVER

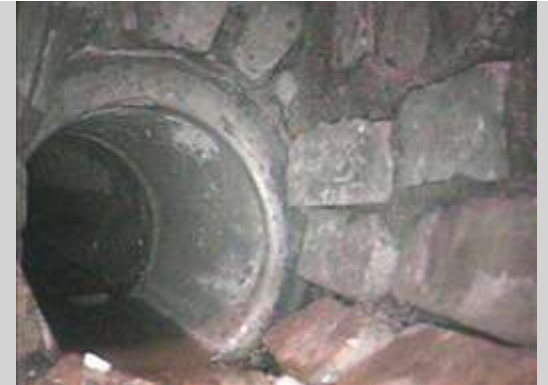
12 O'Clock Outflow

Pipe Height: (in.) Direct
Pipe Material: **Clay** ☐ Pipe Lined
Invert Depth: **9.46** (ft.) Flow Characteristics: **Slow**
Deposits: ☒ None ☐ Mud ☐ Sludge ☐ Debris ☐ Grease
Silt Depth: (in.) Deposits Extent:
Infiltration: **None** Pipe Seal Cond: **Sound**

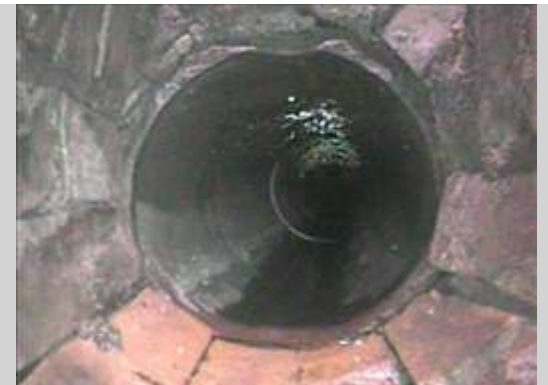
9 O'Clock Inflow

Pipe Height: (in.) Direct
Pipe Material: **Clay** ☐ Pipe Lined
Invert Depth: **9.29** (ft.) Flow Characteristics: **Slow**
Deposits: ☒ None ☐ Mud ☐ Sludge ☐ Debris ☐ Grease
Silt Depth: (in.) Deposits Extent:
Infiltration: **None** Pipe Seal Cond: **Cracked**
